NCHRP RESEARCH REPORT 834

**Crossing Solutions
at Roundabouts and Channelized
Turn Lanes for Pedestrians
with Vision Disabilities**

A Guidebook

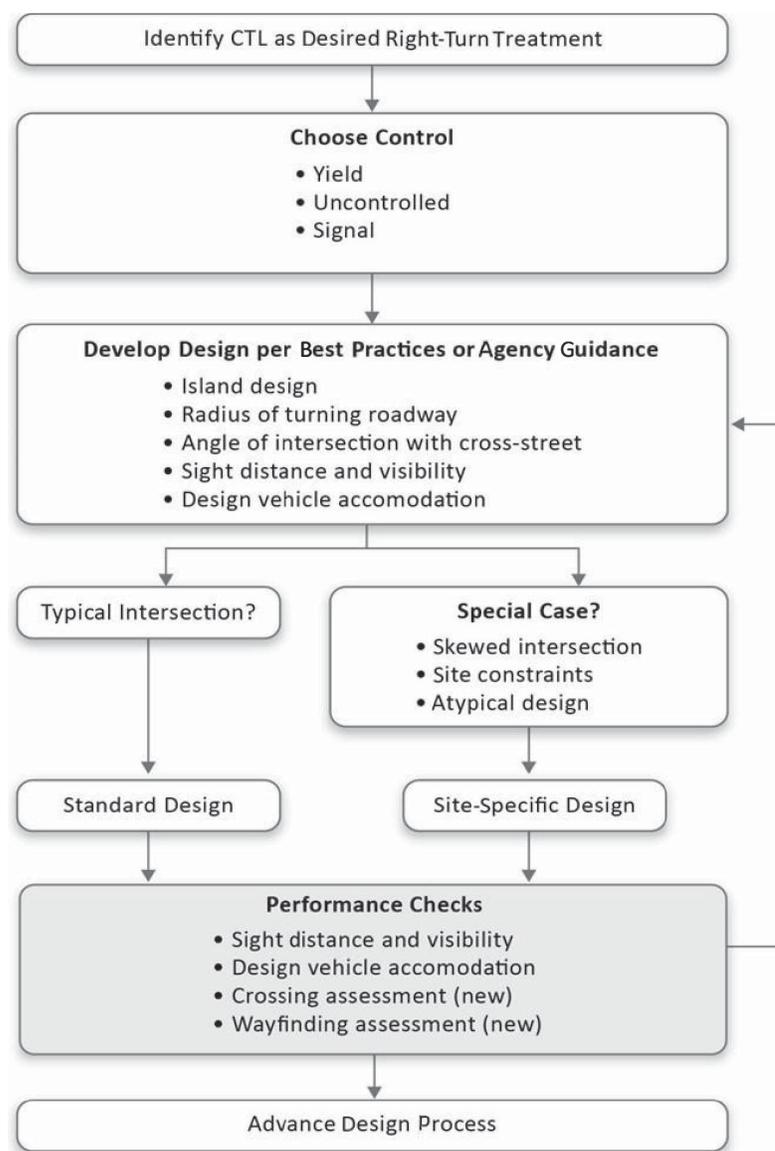
Figure 2-2. Channelized turn lane design process.

The key aspects of this figure are selection of control and design development according to established practices. Operational needs, land use and contextual environment, and agency preferences are all factors influencing the selection of control. The Green Book, agency guidance documents, and typical detail drawings are factors influencing the selection of island size, turning roadway width and radius, and crosswalk location, to name a few of the elements of CTLs. In some cases, site-specific conditions necessitate variations of established practices. For example, if an intersection is skewed, the turning roadway width and radius required to accommodate a design vehicle may need to be determined with vehicle turning template software rather than the orthogonal intersection figures in the Green Book.

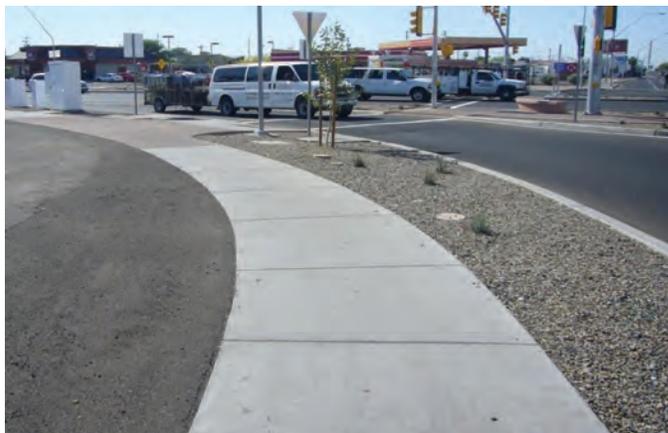
Figure 3-6. Detectable sidewalk separation at a CTL with gravel surface.

Figure 3-6 shows a CTL with adequate landscape separation provided through a gravel surface.

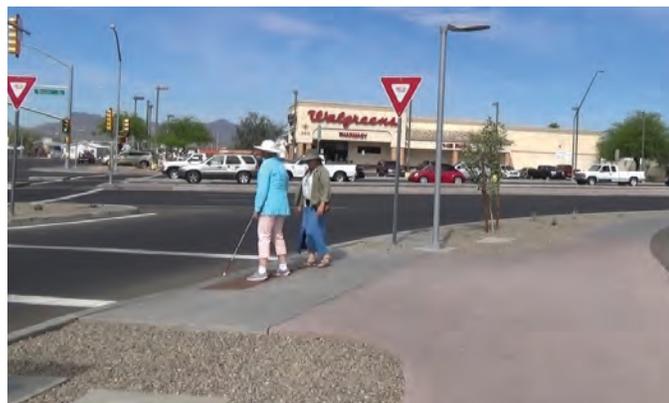
Figure 3-10. Blind pedestrian aligning to cross at a CTL.

Figure 3-10 shows a blind pedestrian aligning to cross at a CTL with detectable warning surfaces, ramp and gutter aligned with crossing, and the crosswalk perpendicular to the traffic flow.

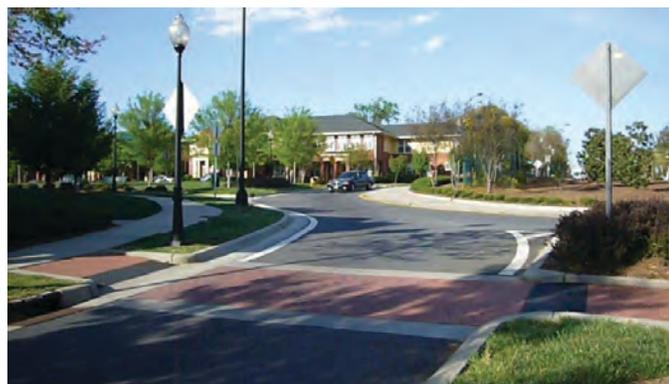
Figure 3-12. Single-lane roundabout with frequent all-quiet periods.

At unsignalized crosswalks, the typical technique taught to pedestrians who are blind or who have low vision is to cross when there is no traffic audible on the street they are crossing (Allen, 1997; Hill and Ponder, 1976; Jacobson, 2013). This applies to crossing the uncontrolled leg of a two-way stop-controlled intersection, crossing at a mid-block crosswalk, or crossing at a roundabout or CTL. In other words, the recommended strategy is to wait for a long gap or an all-quiet period, which is a technique observed by several participants in roundabout studies as well (Schroeder et al., 2011). Of course, this strategy tends to become less effective as traffic volume increases and large gaps become rare (Figure 3-12).

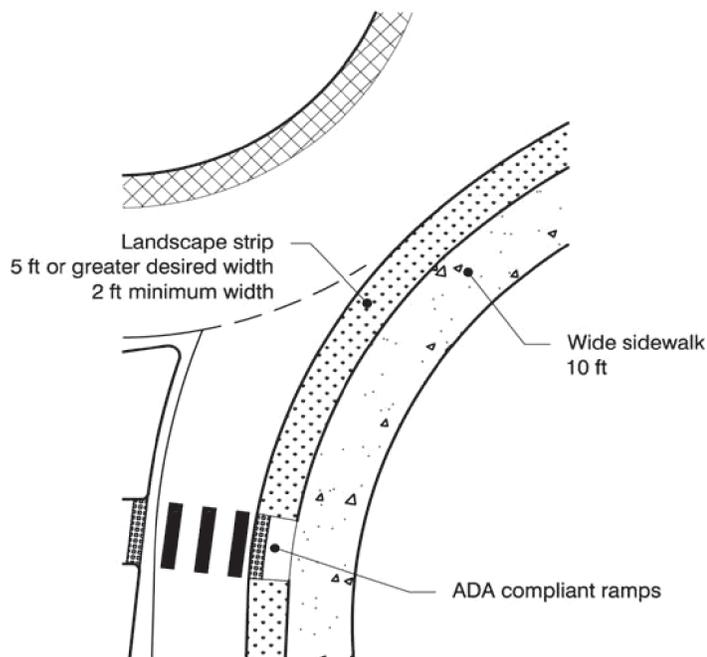
Figure 4-6. Roundabout with landscape buffer following roadway curvature.

Figure 4-6 shows a sidewalk that follows the curvature of the roadway in the roundabout but is separated by approximately a 4 ft to 5 ft wide landscaping buffer.

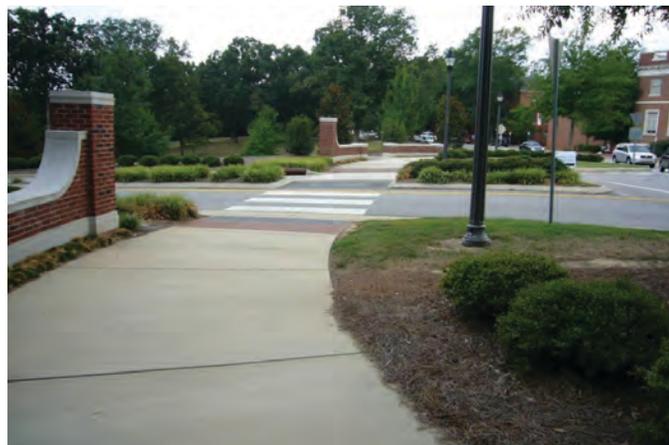
Figure 4-8. *Sidewalk curving away from the corner to guide pedestrians directly to the crosswalks.*

At the roundabout corner visible in Figure 4-8, the sidewalk between the crosswalks on either side of the corner curves in the opposite direction from the curb line. This results in a very wide area of grass and other landscaping between the sidewalk and the curb of the circulatory roadway, making it unlikely that any pedestrian will be inclined to cross to the central island. A pedestrian who is traveling toward the roundabout from either approach will find that the grass strip along the curb line ends where the crosswalk begins to cross the street beside them. If they wish to cross the intersecting street, the continuation of the sidewalk turns away from the roadway and curves around to lead them directly to, and in line with, the crosswalk for the intersecting street. As noted in the text, the splitter island cut-through is as wide as the crosswalk and there are low plants on the non-walking areas of the island.

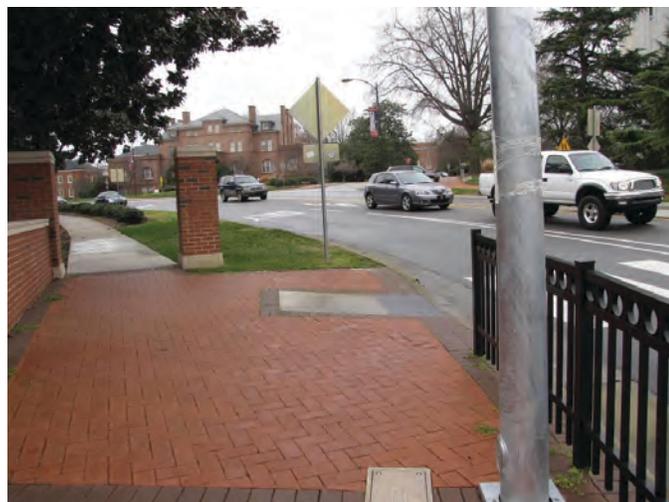
Figure 4-11. Fencing and grass strip at a roundabout corner.

Fencing, shown in Figure 4-11, or bollards connected by chains where crossing is not intended, indicates to all pedestrians that they should not cross in locations so marked. Bollards alone are not sufficient indications to blind pedestrians that they are in a non-crossing location (unless they are less than approximately 24 in. apart) as they may pass through without encountering a bollard. When chains are used between bollards, the lower edge should be no higher than 15 in. above the sidewalk, as required by PROWAG-NPRM R306.3.1. Chains that are more than 15 in. above the sidewalk may not be detected by a user, because the long cane may slide under the chain without touching it. A higher chain should also be provided so it is readily visible to aid pedestrians who are not using a long cane in detecting it. Bollards and chains should contrast with surrounding surfaces so that they can be seen by travelers with reduced vision who do not use a long cane or dog guide.

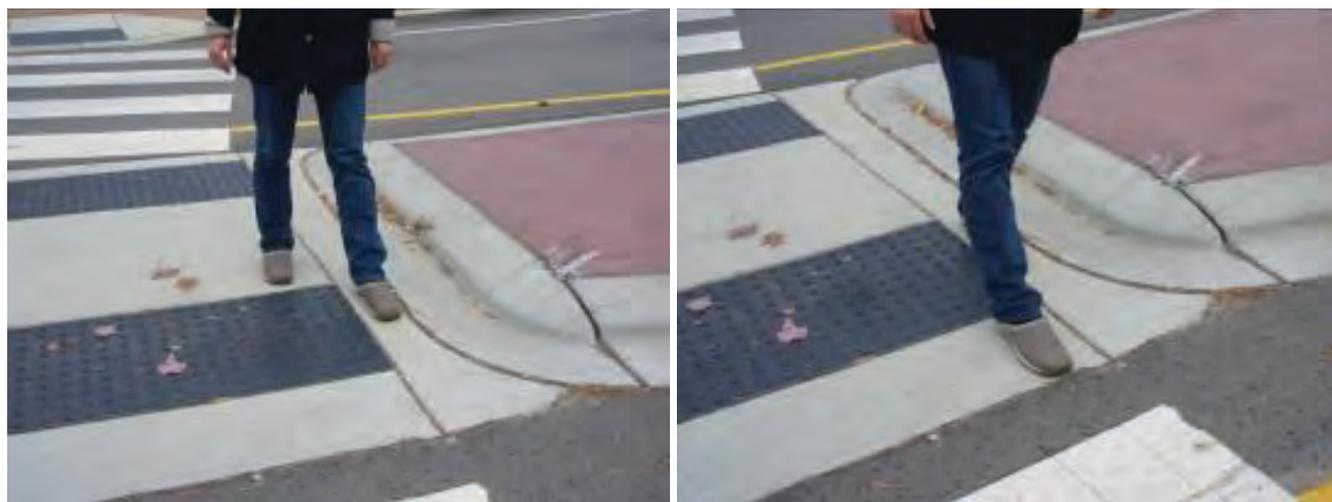
Figure 4-12. Example of incorrect detectable warning surface installation at a roundabout crossing.

Figure 4-12 shows an example of a pedestrian stepping past an incorrect installation of a detectable warning surface at a roundabout crossing. The detectable warning surface does not cover the entire cut-through area at a splitter island, and the pedestrian’s left foot is just to the left of the detectable warning surface in the picture on the left. In the picture on the right, the pedestrian has taken a step and the right foot is past the detectable warning at the street edge. The pedestrian thus may not detect the edges of the island and may continue into the travel lanes.

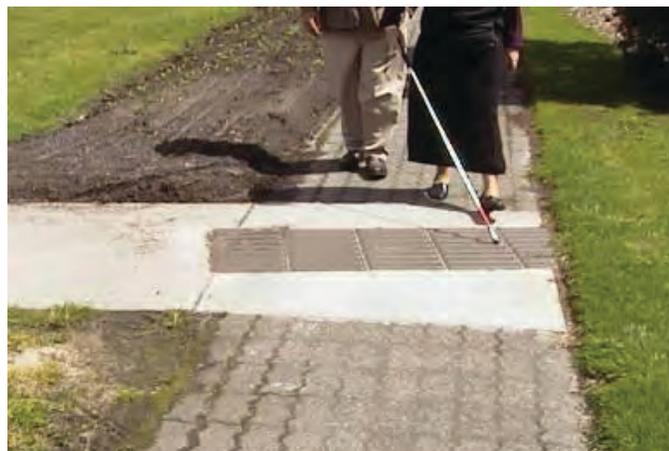
Figure 4-13. Australian bar tile surface.

Figure 4-13 shows an example of an Australian bar tile surface installed across a sidewalk to indicate the location of the crossing at the roundabout (outside of frame on the left). A person using a long cane is approaching the surface with the cane tip contacting the bar tile surface. The bar tile surface is 2 ft wide in the direction of pedestrian travel and extends across the entire width of the sidewalk. Bars are aligned with the direction of the crosswalk.

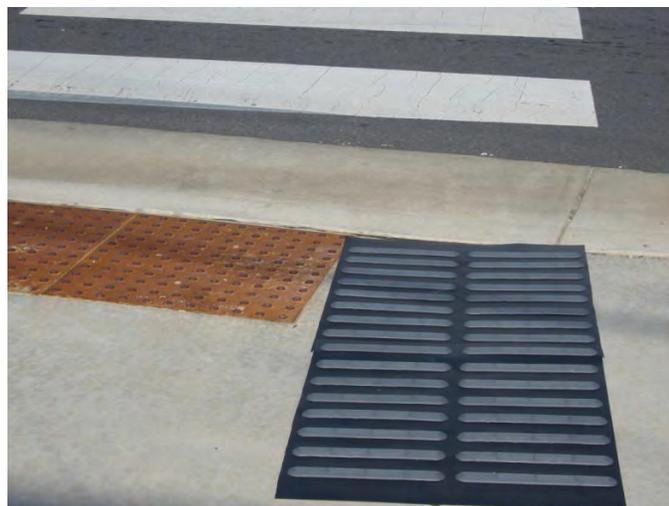
Figure 4-14. Experimental bar tile with bars perpendicular to the direction of the crosswalk.

A variation of the tile shown in Table 4-13, with bars perpendicular to the direction of the crosswalk, is shown in Figure 4-14, as both an indication of the location of the crosswalk and to provide alignment information to blind pedestrians. Bar tiles are optional treatment and are not subject to the same requirements as detectable warning surfaces.

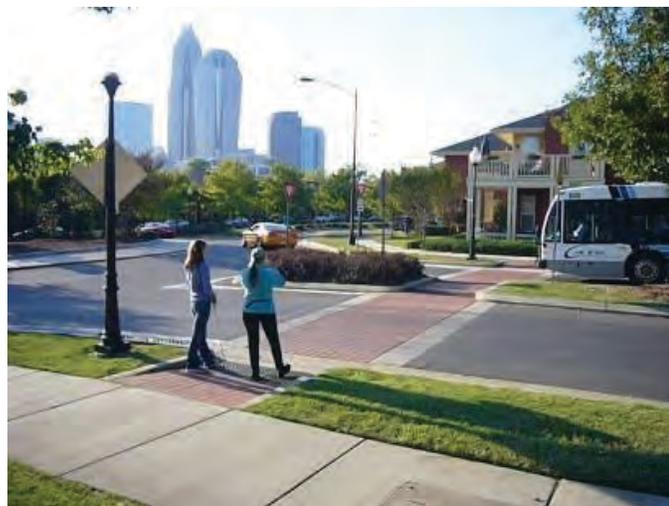
Figure 4-15. Curb ramp with returned curbs.

Figure 4-15 shows a pedestrian waiting to cross an exit lane from the corner to the splitter island. On each side of the curb ramp is a sloping curb with vertical sides between the ramp and the grass, which is aligned with the direction of travel on the crosswalk. The cut-through in the splitter island is also bounded by returned curbs so that following the curbing all the way across the island could aid in maintaining crossing direction. There is grass on both sides of the ramp, which reduces the likelihood of pedestrians approaching the ramp from a less than optimal direction.

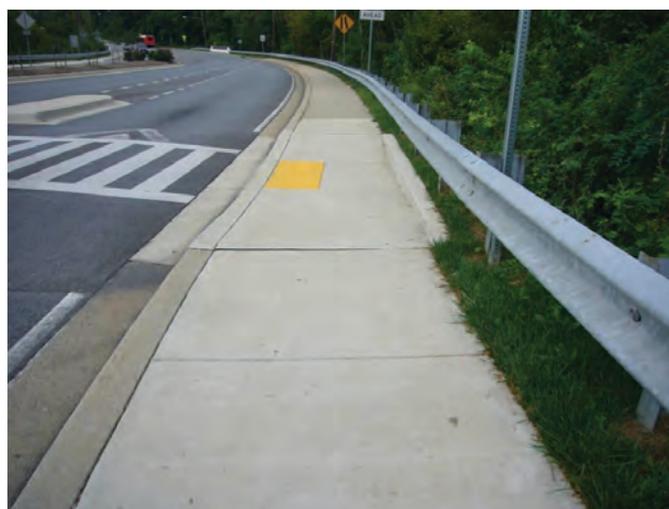
Figure 4-16. Parallel curb ramp.

Figure 4-16 shows a parallel curb ramp at a roundabout crossing. A parallel ramp is often used when there is a narrow sidewalk at the back of curb. The entire sidewalk slopes down to a level landing at the crosswalk location. The detectable warning surface is installed along the curb line for the entire width of the level area. As noted in the text, there is no landscaping or barrier between the sidewalk and the curb, so a blind person is not guided to the crosswalk location.

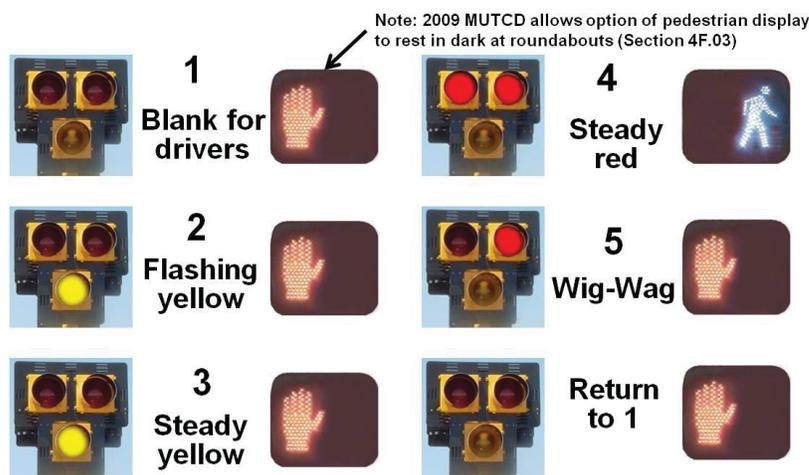
Note: No green ball to cause possible confusion with yield sign

A note at the bottom of the graphic states: No green ball to cause possible confusion with the yield sign.

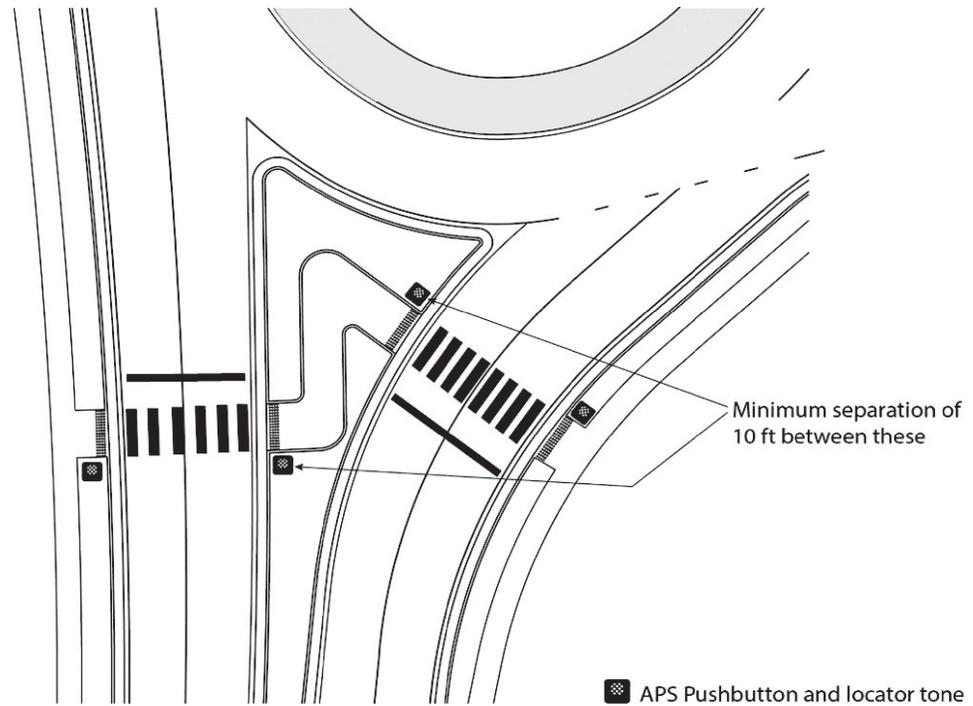
Figure 4-26. Location of pedestrian pushbuttons for zig-zag crossings.

If a crosswalk has a signal or beacon and APS or audible information devices are provided in the splitter island for a two-stage crossing, a wider splitter island is needed. The pushbuttons and audible messages must be separated by at least 10 ft, and poles must be set back from the curb by 2 ft to reduce the likelihood of being struck by vehicles and to properly locate pedestrian pushbuttons (see MUTCD, Sections 4D.16 and 4E.08 through 4E.10). Therefore, with a signal or beacon and a straight pedestrian crossing, the minimum recommended width of the splitter island at the crosswalk location is 14 ft. Moving the exit portion of the crosswalk further away from the roundabout in a zig-zag island design can aid with providing adequate space for the required separation of entry and exit traffic control devices for pedestrians. The zig-zag may also allow for an island that is less than 14 ft wide, while still providing adequate separation, as illustrated in Figure 4-26.

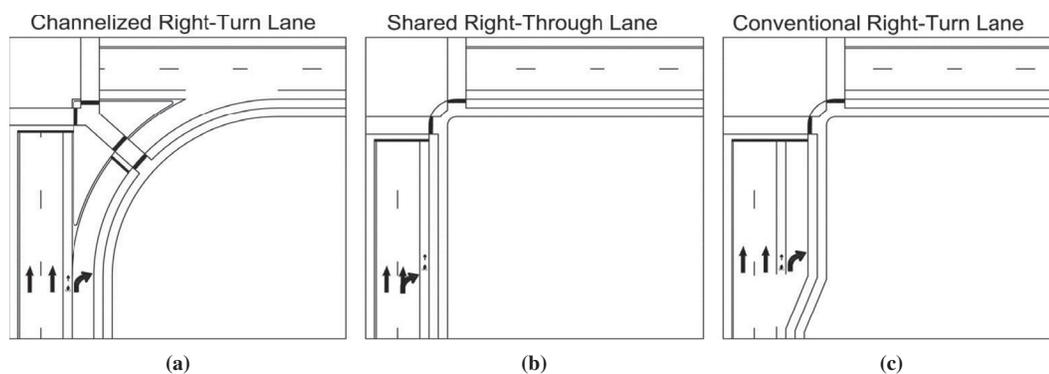
Figure 5-1. Types of right-turn lanes.

Recent research (Potts et al., 2011) found that CTLs had a lower motor vehicle crash frequency than conventional right-turn lanes and higher motor vehicle crash frequency than shared right-through lanes. In other words, once a decision has been made that a designated right-turn lane is needed for capacity, a CTL provides a safer configuration than an exclusive right-turn lane without channelization. Figure 5-1 depicts these three types of right-turn lanes.
